PASSAIC RIVER BASIN  
RAMAPO RIVER, BERGEN COUNTY  
NEW JERSEY

# LAKE VREELAND

## PHASE I INSPECTION REPORT NATIONAL DAM SAFETY PROGRAM

NJ 00229

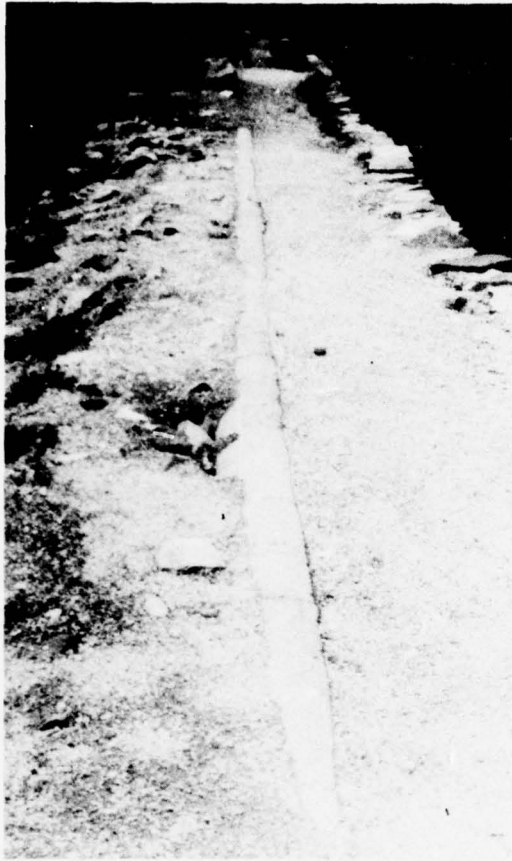
The riprap is stacked vertically and the corewall is exposed over 50 percent of its length. The tilt of a portion of the corewall as evidenced at the crest cast doubts with respect to the integrity of the concrete corewall. The foundation of the concrete corewall may have experienced excessive differential settlement if the wall is founded partially on blue clay and bedrock.

EXPOSED CONCRETE CORE

d. Engineering investigations and studies should be made of the condition of the tilted concrete corewall as well as determination of the properties of the embankment as is pertains to the structure's stability. These investigations and studies should be completed within six months from the date of approval of this report. Any remedial measures found necessary as a result of these investigations and studies should be initiated within calendar year 1979.

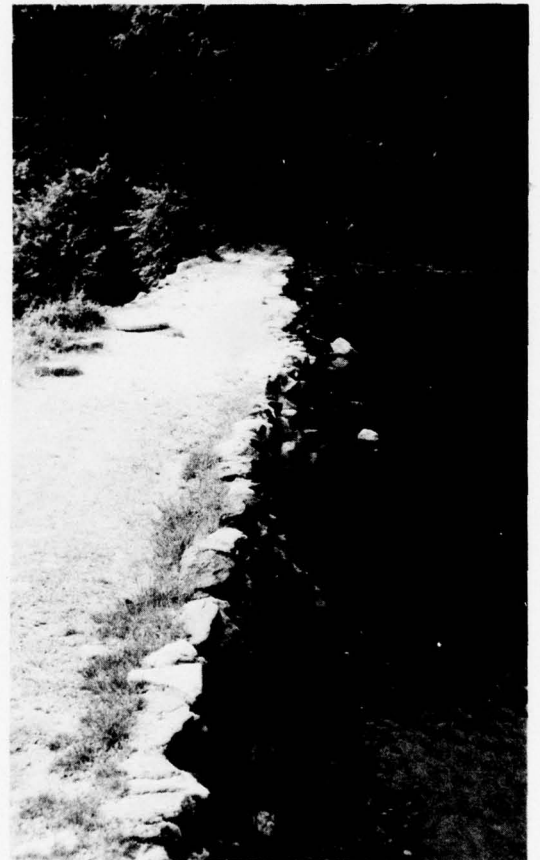
VISUAL EXAMINATION OF	OBSERVATIONS	REMARKS OR RECOMMENDATIONS
RIPRAP FAILURES	Three feet of riprap visible, stacked vertically resting on gently sloping shelf of soil (±3.5 feet wide) on wet side.	The upstream slope was constructed to 2 horizontal: 1 vertical and the entire slope was protected with paving 9 inches thick.
CORE WALL	Visible in two locations, about 25-foot sections. The section nearest the right abutment shows a 10°± angle with the vertical, and the top of the wall section is not level, but slopes towards the downstream side.	Possibility exists that the core wall has cracked, and that water is seeping through said crack with resultant piping etc.
JUNCTION OF EMBANKMENT AND ABUTMENT, SPILLWAY AND DAM	No distress or seepage noted	
ANY NOTICEABLE SEEPAGE	<ol style="list-style-type: none"> <li>1 Minor seepage located at the foot of the slope about 70 feet downhill from the toe of the slope.</li> <li>2 A series of springs flowing at estimated 15-20 gpm is visible in the middle of the parking area, and 220 feet below the toe of the dam.</li> </ol>	The Boy Scout Camp Ranger did not remember if this spring was flowing during deepening of lake in 1976. Lake was drained at the time.

VIEW OF UPSTREAM RIPRAP  
AND VERTICAL DAM FACE
